National Transportation Safety Board Aviation Accident Preliminary Report

| Location: | Howell, MI | Accident Number: | CEN19FA279 |
| Date & Time: | 08/20/2019, 1118 EDT | Registration: | N200HS |
| Aircraft: | Aero Commander 200 | Injuries: | 2 Fatal |

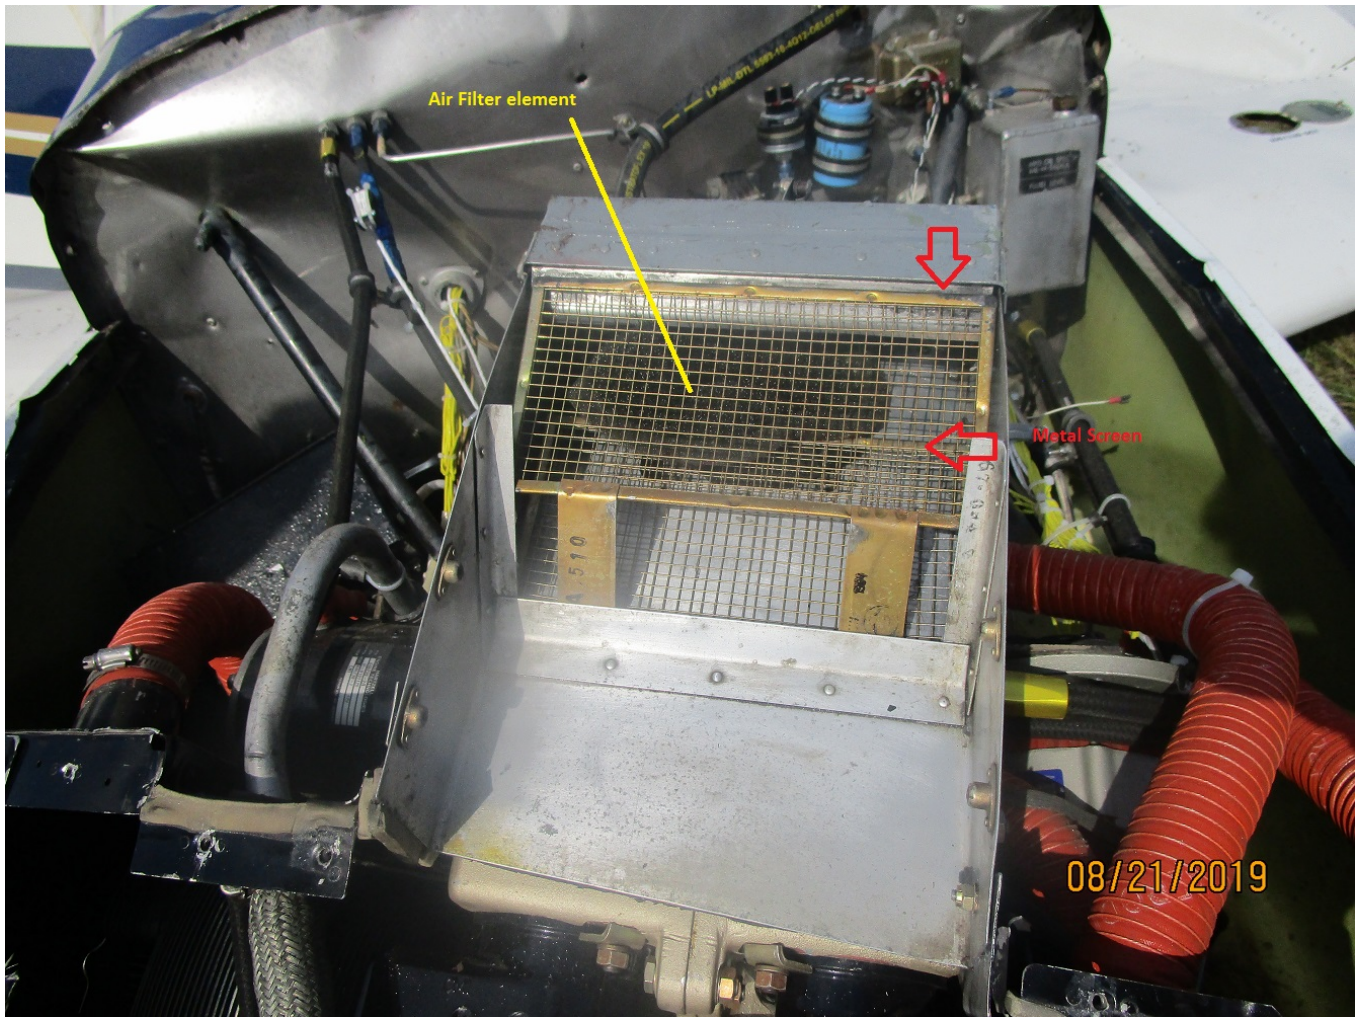
Figure 1: Air intake

The airplane impacted terrain and came to rest about 600 ft beyond the departure end of the runway. The responding Federal Aviation Administration inspector, the NTSB Investigator-in-Charge, and a technical representative from the engine manufacturer examined the airplane wreckage on site. The examination found the engine air filter element was displaced and in the engine intake tube (see figures 1 and 2).

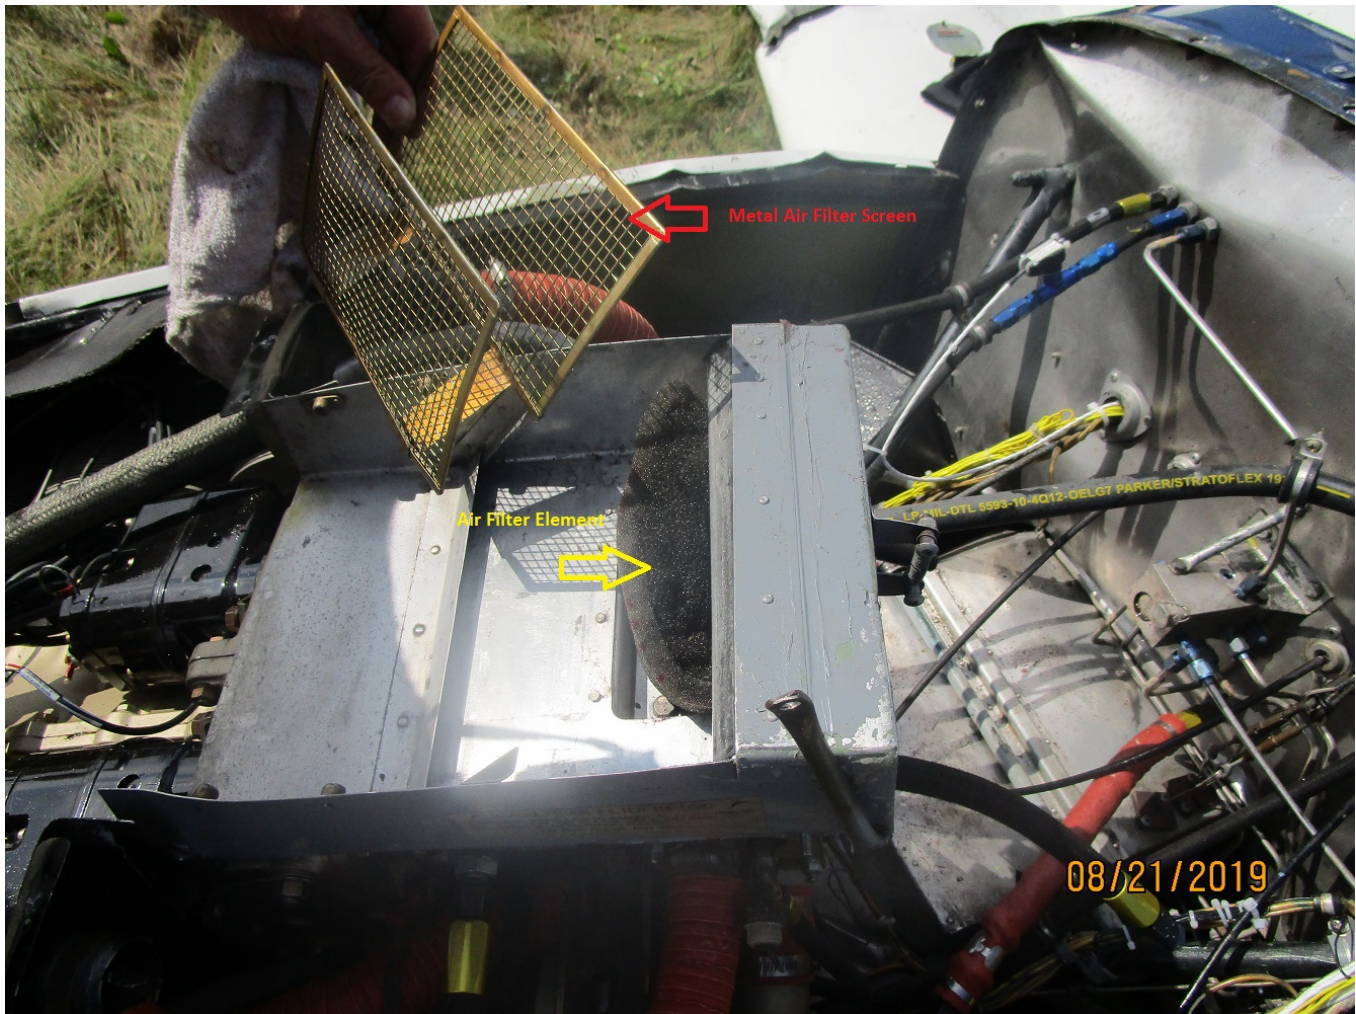
Figure 2: Air intake and air filter element
