National Transportation Safety Board Aviation Accident Final Report

Location:	Howell, Michigan	Accident Number:	CEN19FA279
Date & Time:	August 20, 2019, 11:18 Local	Registration:	N200HS
Aircraft:	Aero Commander 200	Aircraft Damage:	Substantial
Defining Event:	Loss of engine power (total)	Injuries:	2 Fatal
Flight Conducted Under:	Part 91: General aviation - Personal

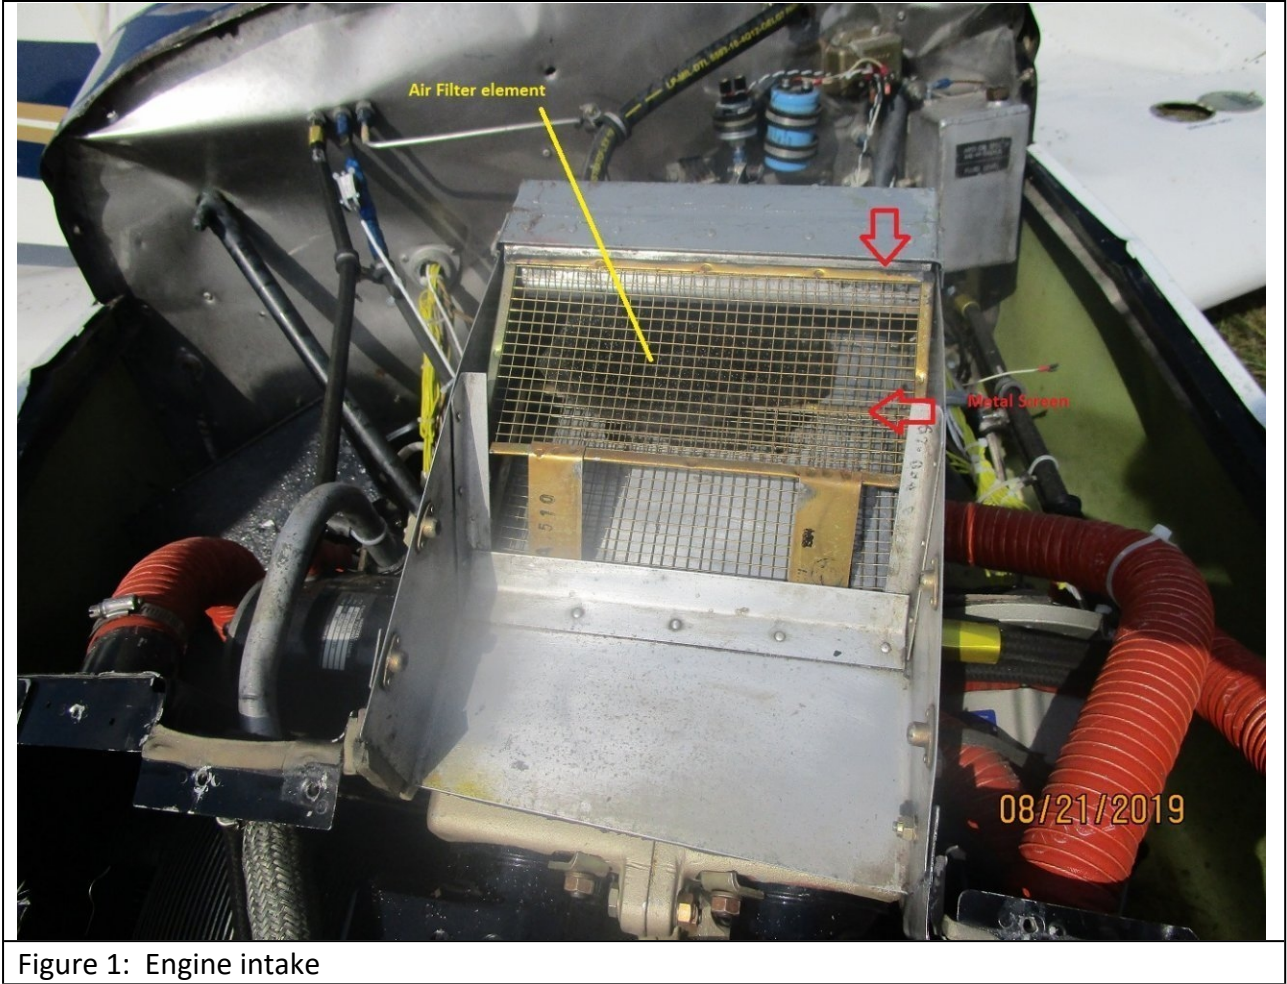
Examination of the airplane revealed substantial damage to the wings and fuselage. During examination of the engine, the air filter element was found displaced and lodged in the intake. The metal screen used to hold the filter element was found improperly installed. The evidence indicates that the improper installation of the metal screen allowed the filter element to become displaced and subsequently lodged in the intake, which blocked the intake air and resulted in a total loss of engine power.

The improper installation of the engine's metal intake screen, which allowed the filter element to become displaced and subsequently lodge in the intake, blocking intake air and causing the total loss of engine power, at low altitude and low airspeed resulting in the airplane impacting terrain.

Examination of the engine revealed that the air filter element was displaced and lodged in the intake tube (see figures 1 and 2).

Figure 1: Engine intake

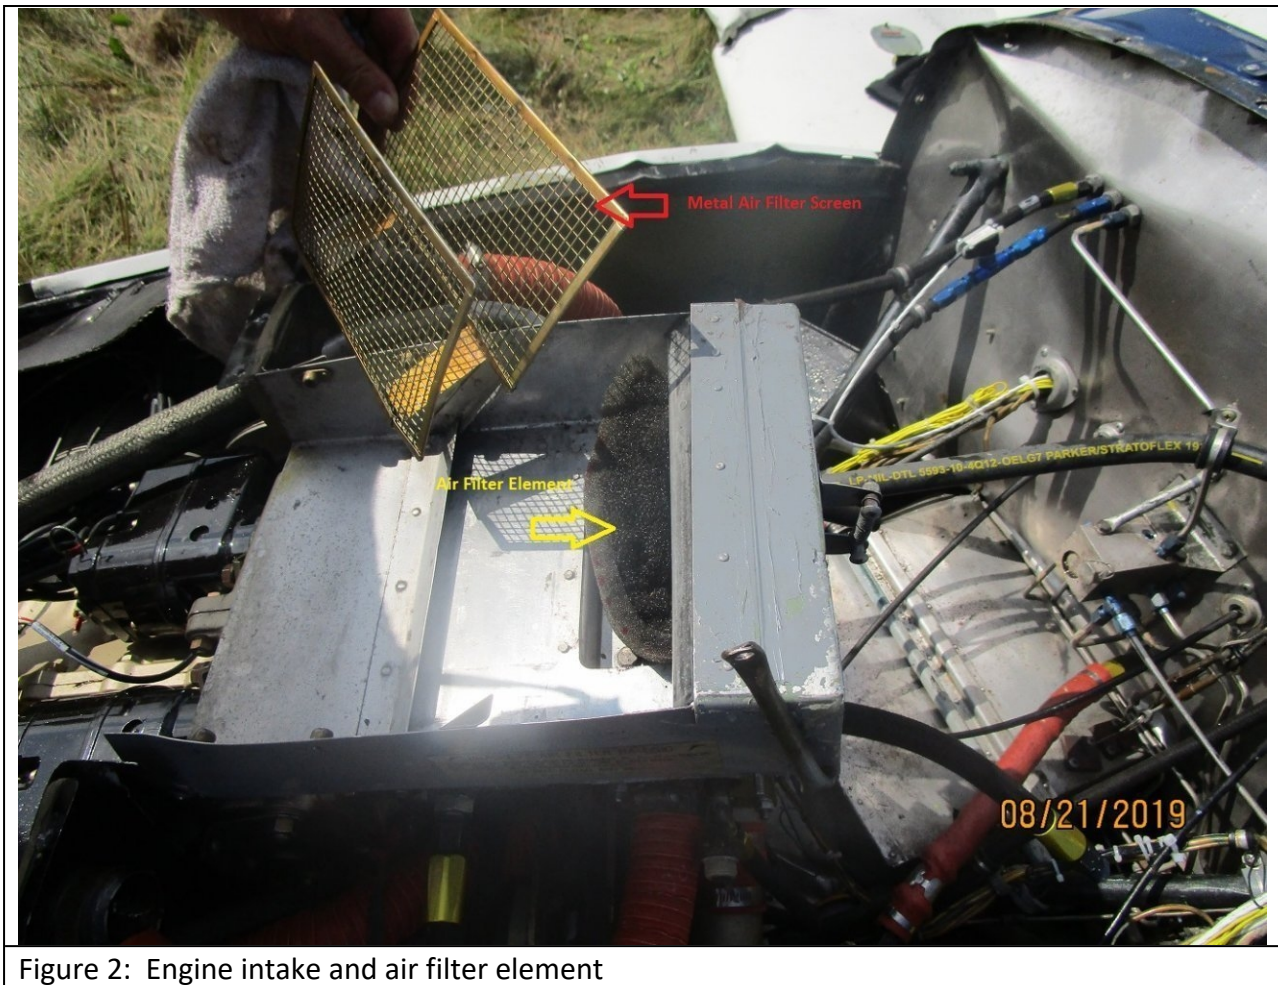
Figure 2: Engine intake and air filter element
